## Property Condition Assessment

## Hopewell Elementary, SLSD

4625 West Hopewell Road, Center Valley, PA 18034

**DATE:** June 5, 2013

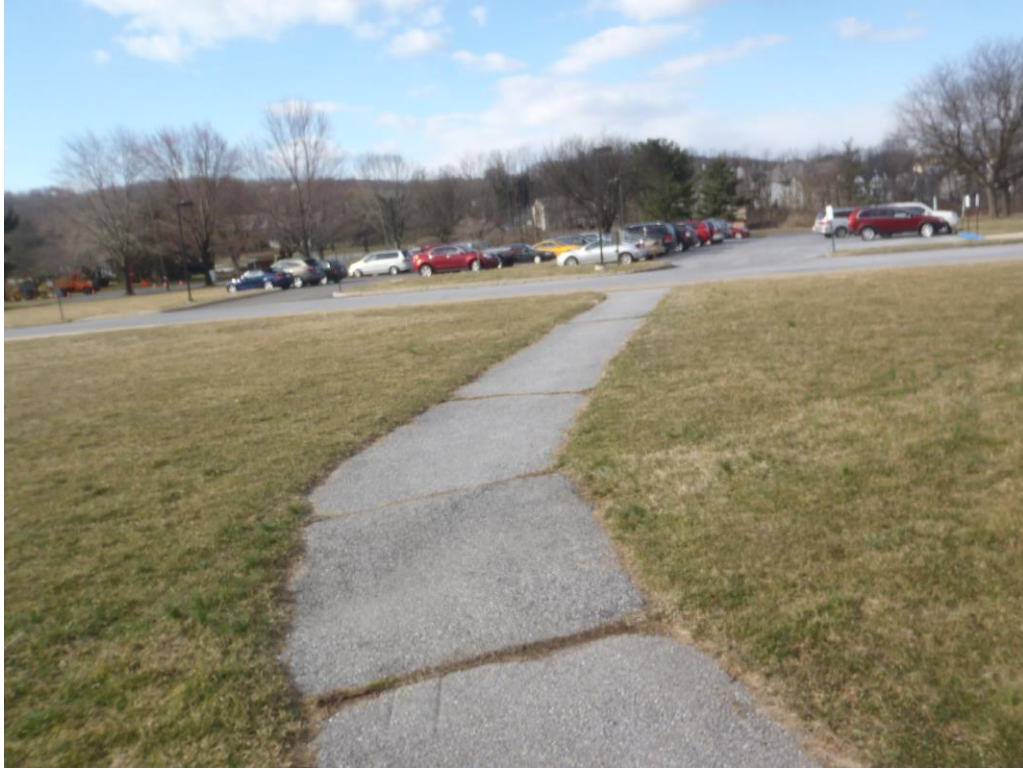
- The concrete paving on site was observed to have heaved in several locations. This is most likely the result of placing the concrete on expansive soils. During the time of the initial construction at Hopewell it was common to use slag from Bethlehem Steel for sub-base material. This slag has proven unsuitable for such uses over time due to its expansive nature and relatively low bearing capacity.
- The concrete paving has spalled, particularly at the edges.
- In general, ADA access does not meet current code.

Exterior pathway, typical

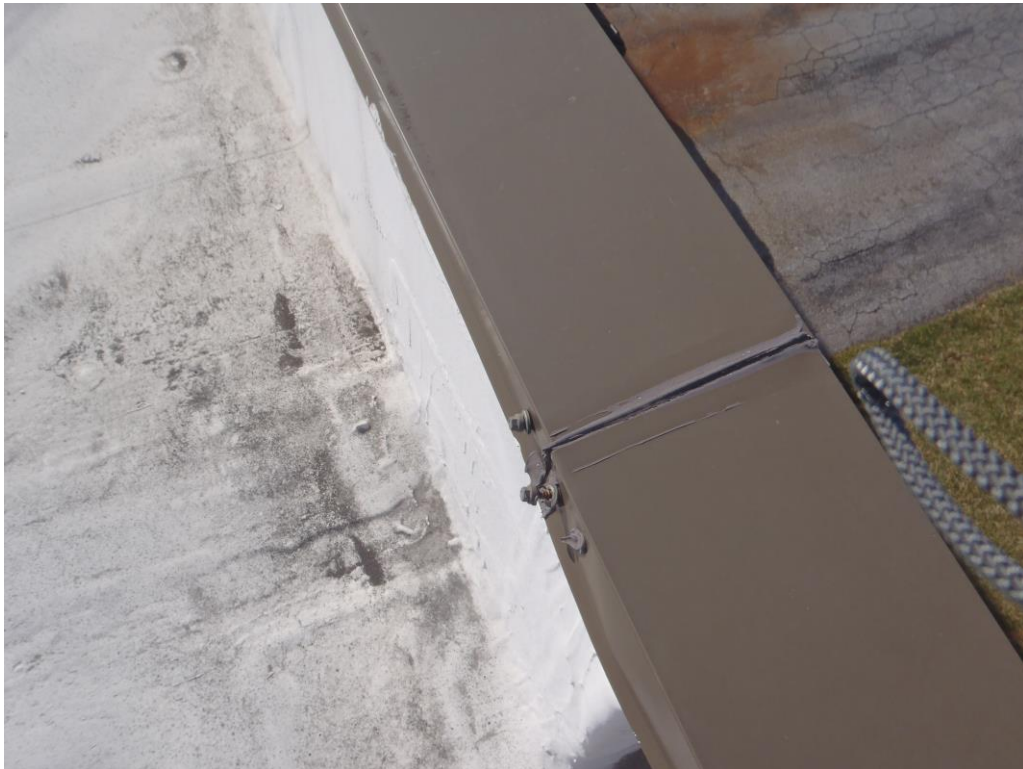
Joint in parapet capping

- The roof was in fair to good condition and should provide at another 5-7 years of service with good maintenance. The joints in the aluminum parapet coping should be sealed to prevent water infiltration at the time that the roof is replaced.

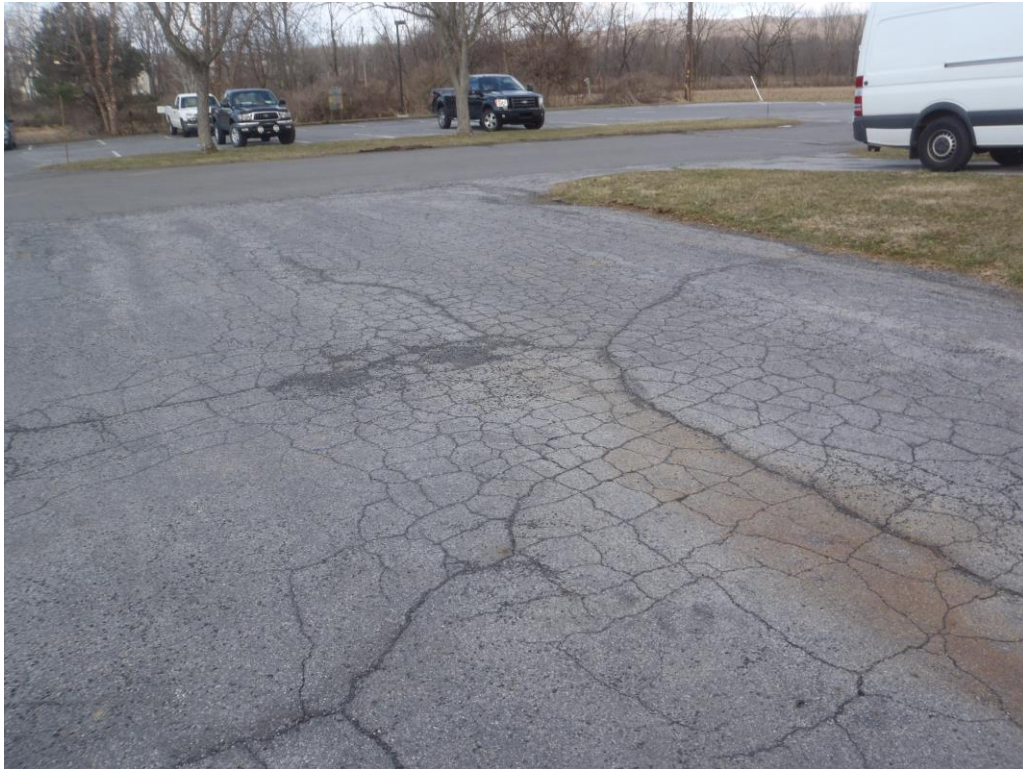
- The asphalt paving on site has reached the end of its useful life. Widespread alligator cracking and the formation of potholes are in evidence.

Asphalt Paving, typical

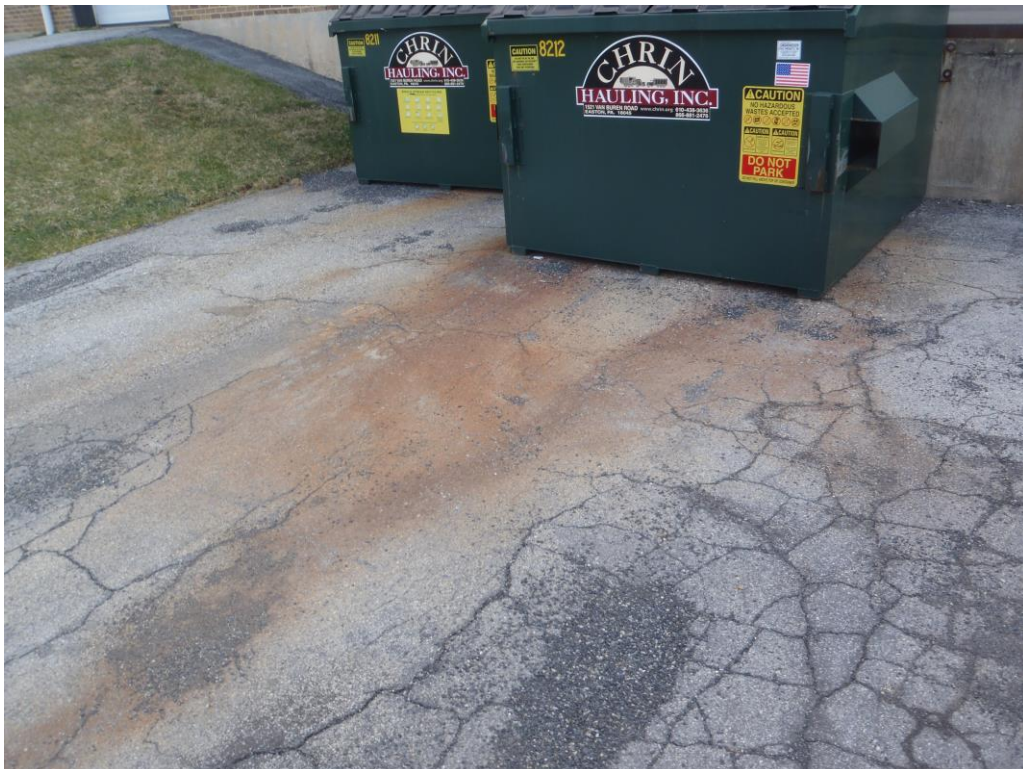
Asphalt near dumpster/loading area. BIA recommends a reinforced concrete pad to withstand the loading in this area.

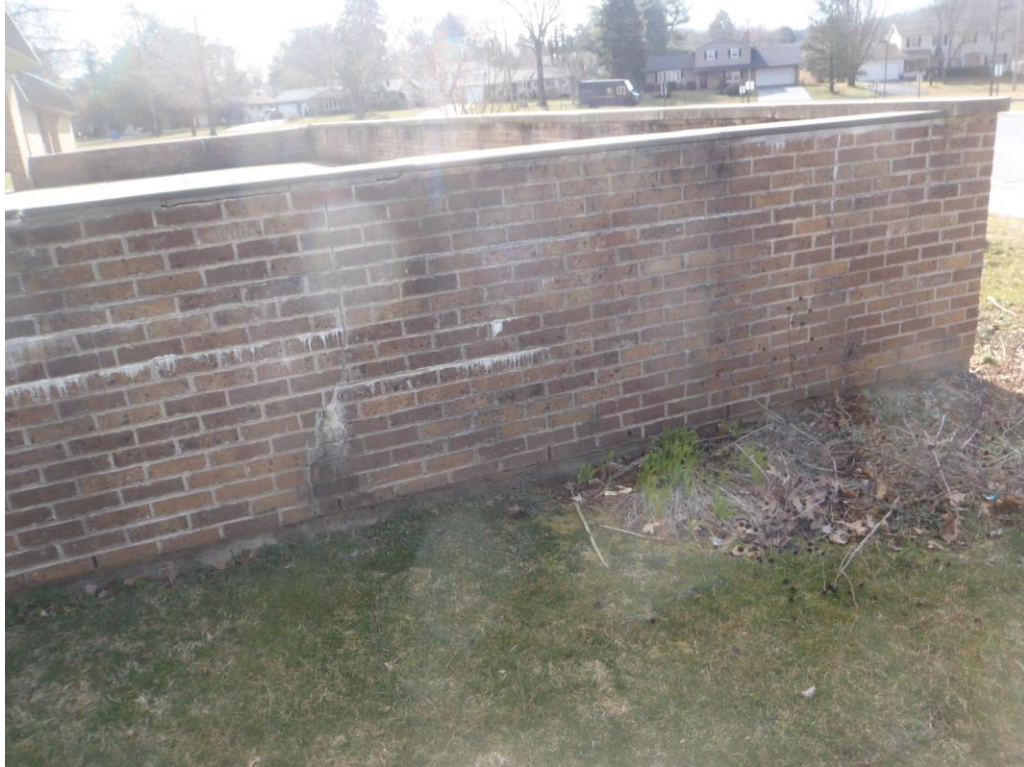
Deteriorated site wall at courtyard near main entrance.

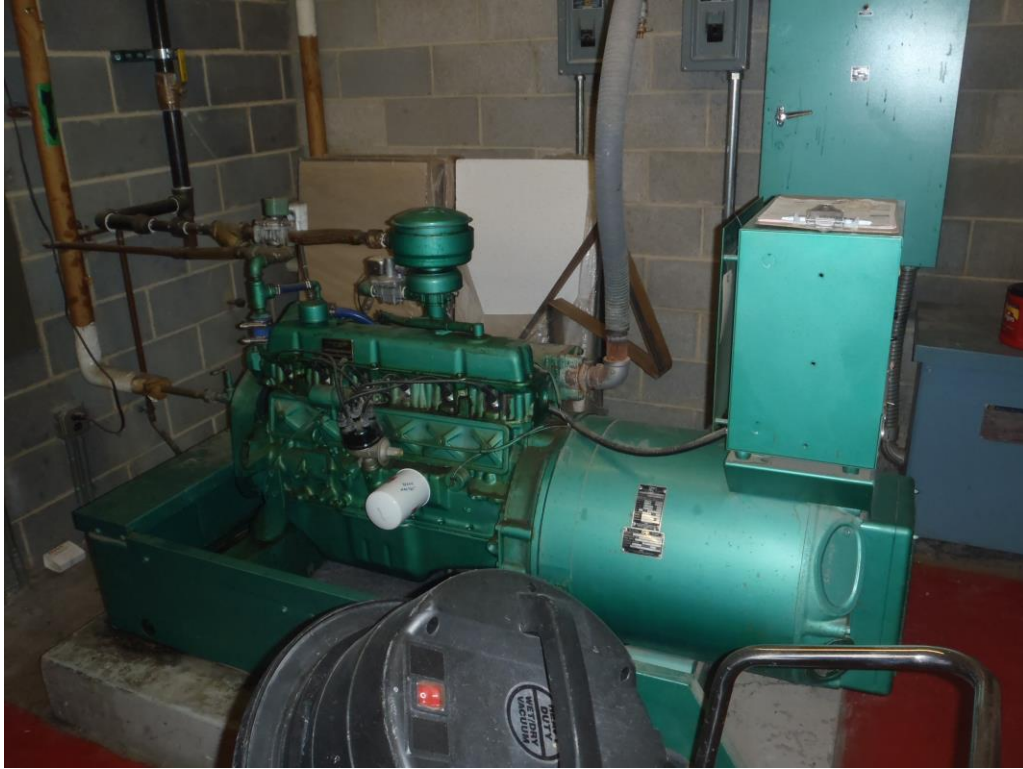
The existing 40 KW natural gas emergency generator appeared to be in fair operable condition; however the generator is original to the building.

Generator

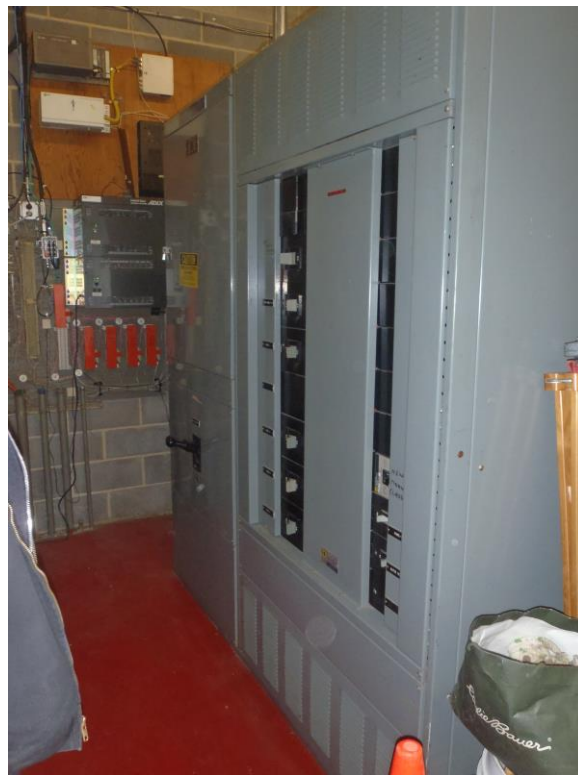
- The main distribution panel and other major electrical distribution equipment are roughly 45 years old. All distribution equipment appears to be in fair condition with no major issues.
- Useful life of electric equipment, based on industry standards, is approximately 50 years. As such, expected useful life for the electrical distribution equipment is 5 years.
- The generator is cooled by a direct pass water cooler which discharges into the sewer system. Should a blockage occur in the sanitary system or

Electrical Distribution near gymnasium.

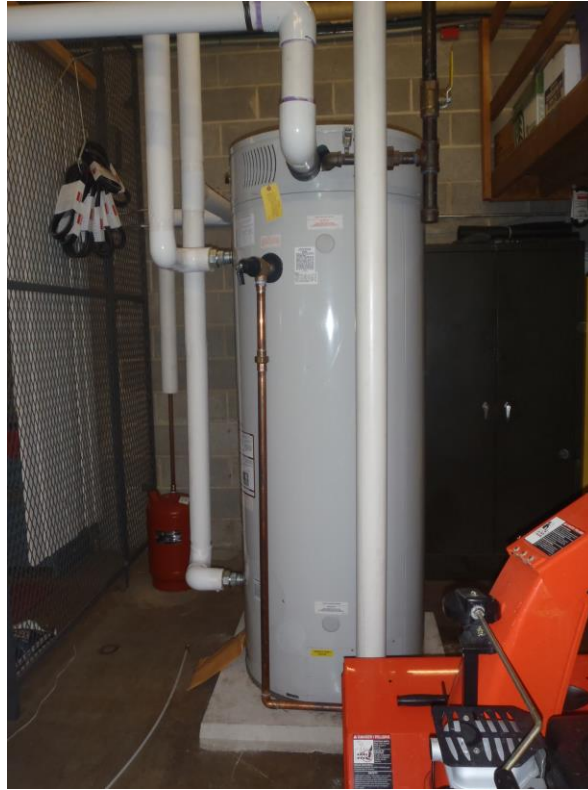
- There are (3) electric water heaters in fair condition and (1) gas fired hot water heater appeared to be in good condition and approximately 2 years old.

Hot water heater

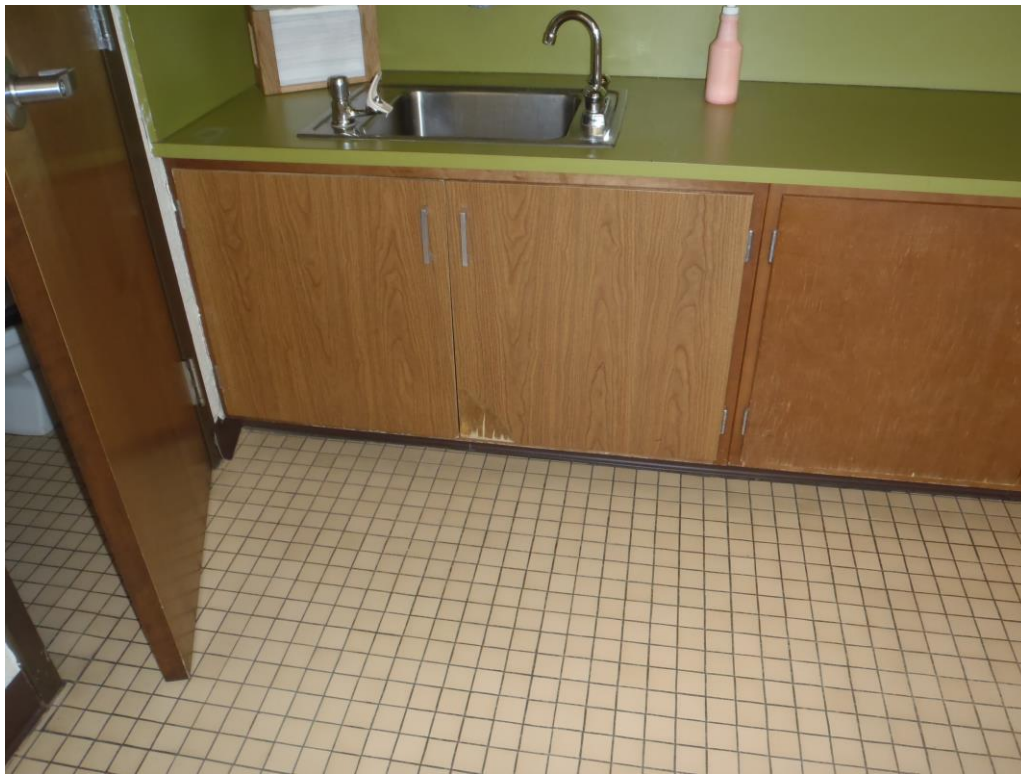
Typical classroom cabinets and sink. Note peeling veneer on doors.

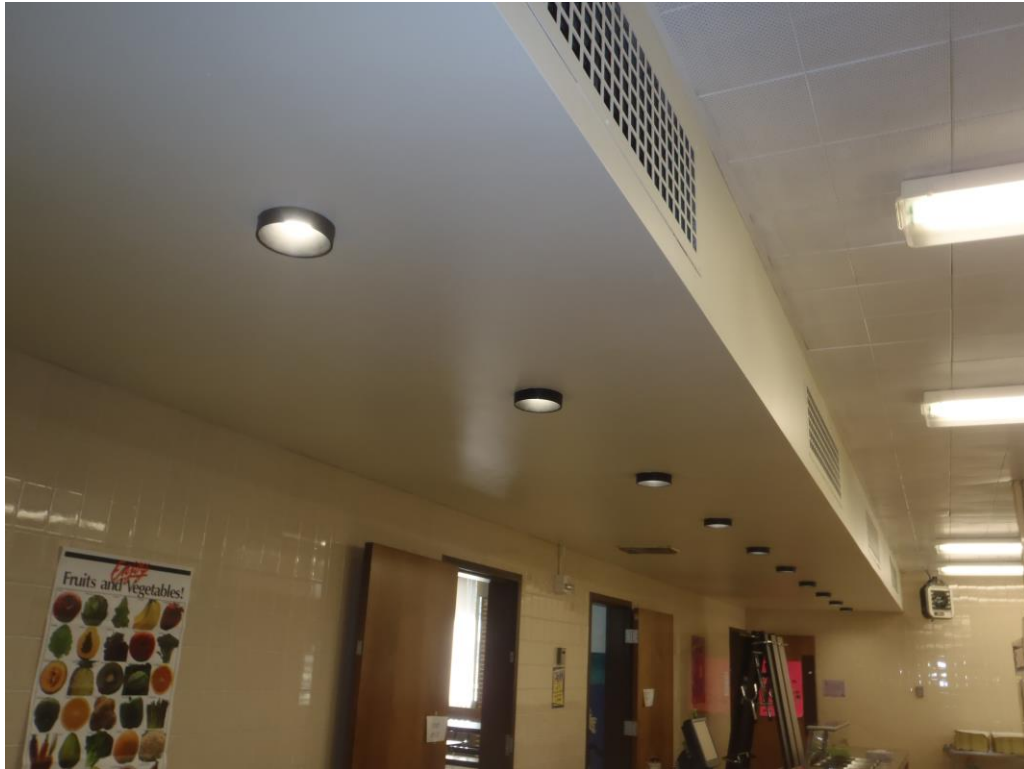
Typical duct system

- A thorough inspection and servicing of all equipment is recommended, but based on the age of the equipment, consideration should be given to a system upgrade to improve system reliability, operation and energy efficiency.
- The ductwork and dampeners range in age but are typically 43 years old and were not engineered to work with the replacement roof top units (RTUs).
- Providing new or additional ductwork will require that additional drop ceiling and other modifications be made to accommodate the passage of ducts.

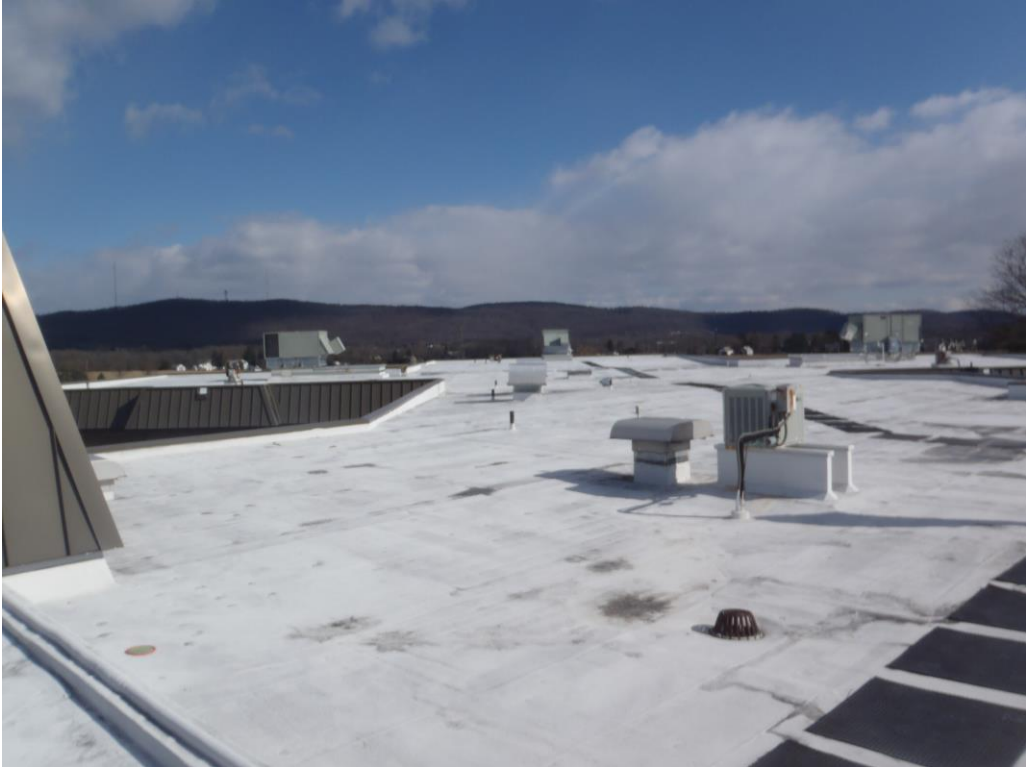
Roof, typical
