Property Condition Assessment

Lower Milford Elementary School

7350 Elementary Road, Coopersburg PA 18036

DATE: June 5, 2013

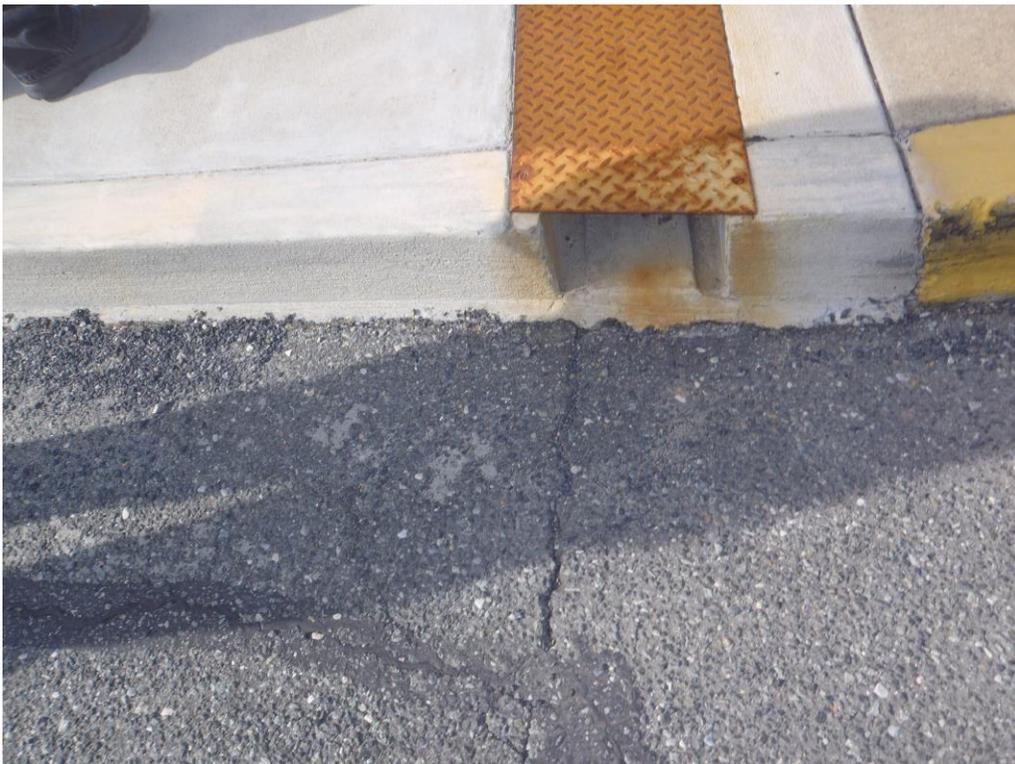
Concrete walk with covered swale for rain leader.

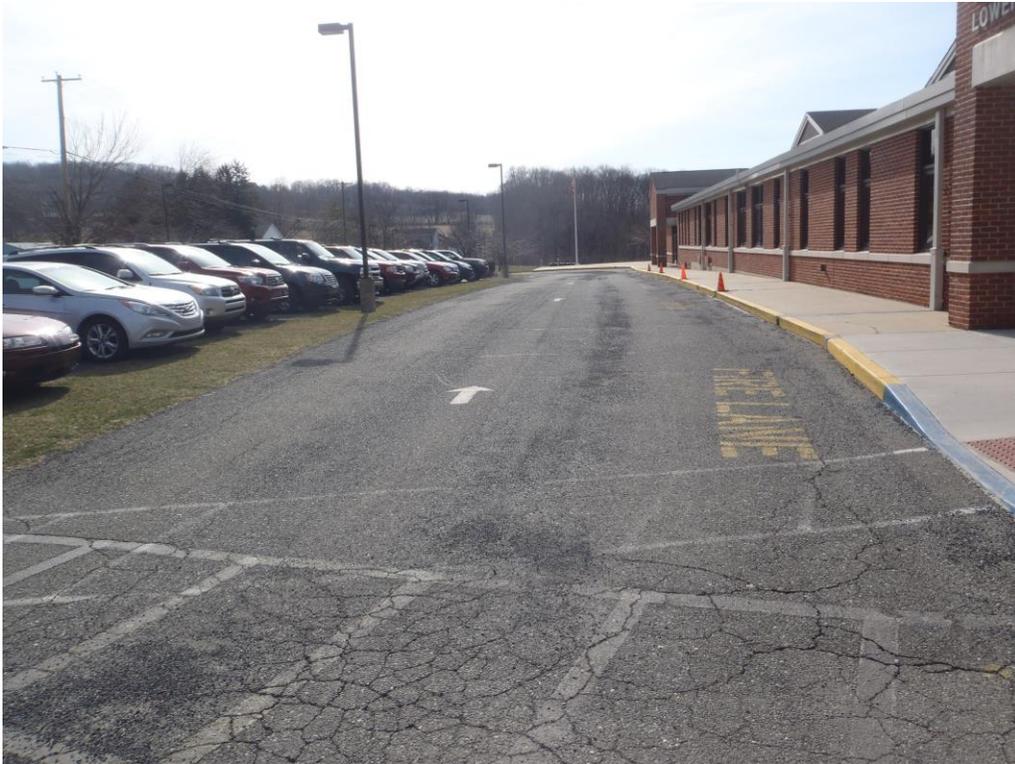
- The asphalt paving on site has reached the end of its useful life. Widespread alligator cracking and the formation of potholes are in evidence.

Asphalt paving, typical. Note the extensive alligator cracking.

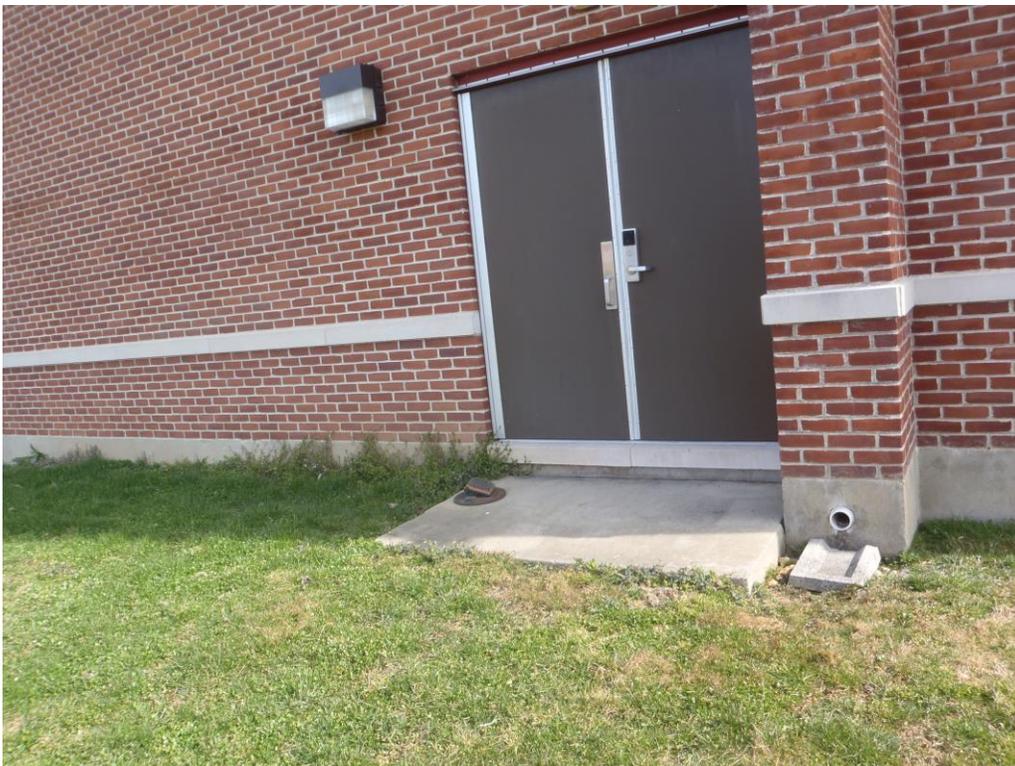
Side entrance. Note the step which limits accessibility.

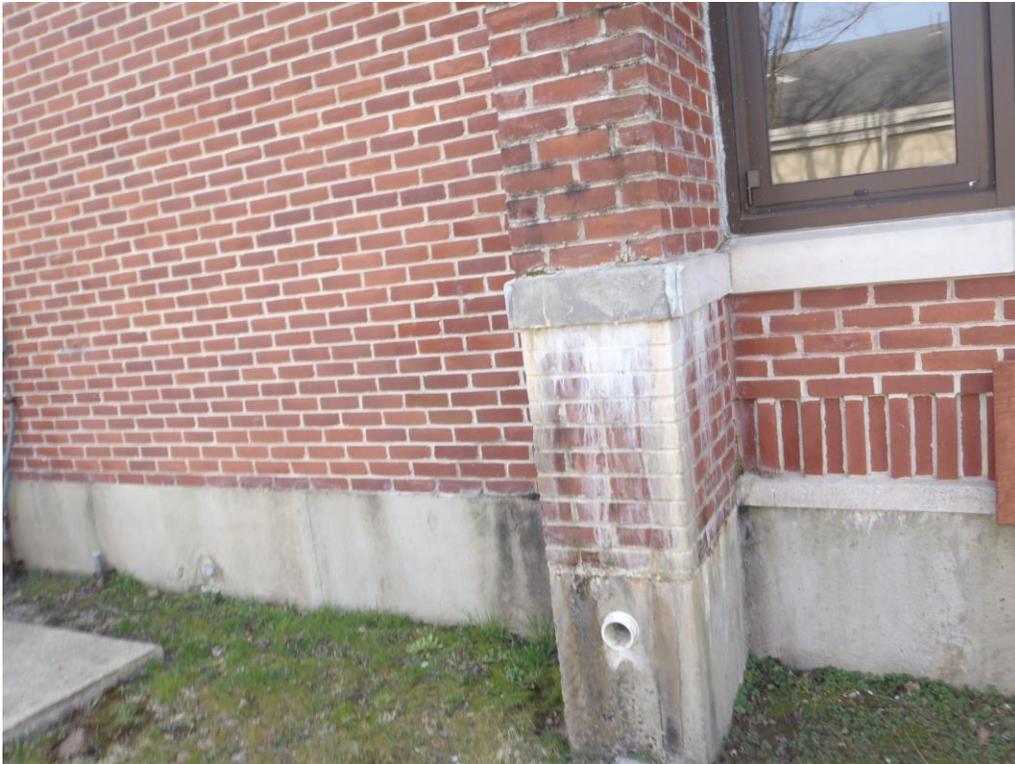
The South façade, particularly the areas in the courtyard between the two wings have areas where the masonry is discolored, stained by soluble salts (efflorescence) and missing mortar joints. These conditions are created by the inability of the masonry to dry because of the amount of shade in these areas. .

Soluble salts resulting from saturation of mortar of extended periods.

- Steel lintels should be examined for corrosion and the surrounding masonry for compressive failure.
- Efforts should be made to channel water away from the walls in the courtyard. Drip tubes, flashings and downspouts in the area of the courtyard should be repaired and possible extended.
- Maintenance repairs such as repointing and rebuilding weep holes should be undertaken in the courtyard.
- All downspouts should be routed so as to flow water away from the walls and foundation.

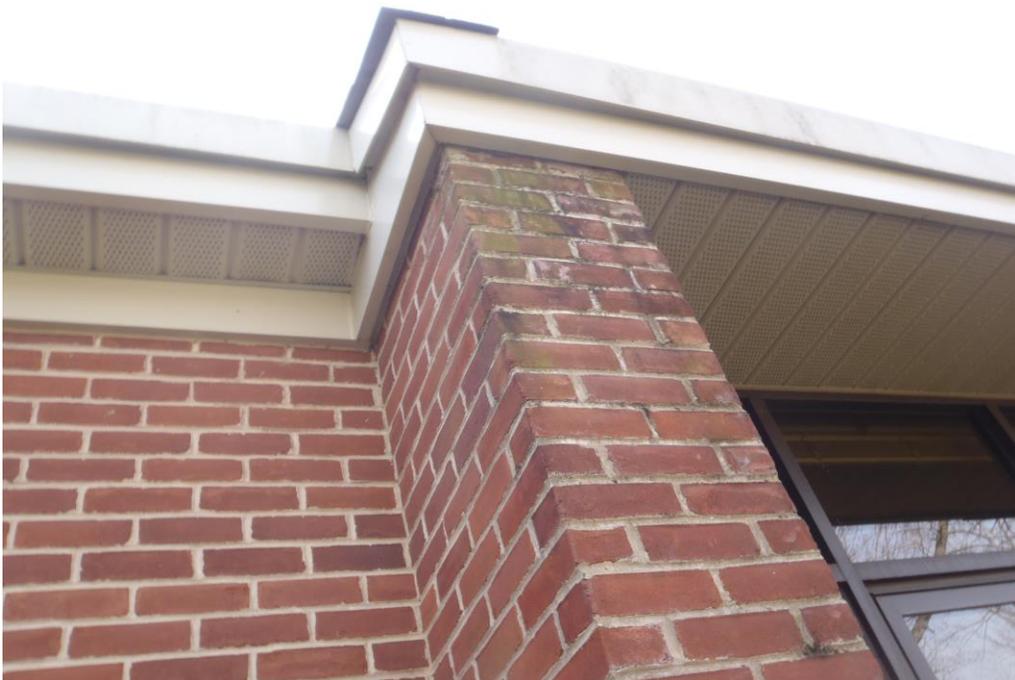
Masonry in area between wings exhibiting staining/loss of mortar resulting from excessive time between drying.

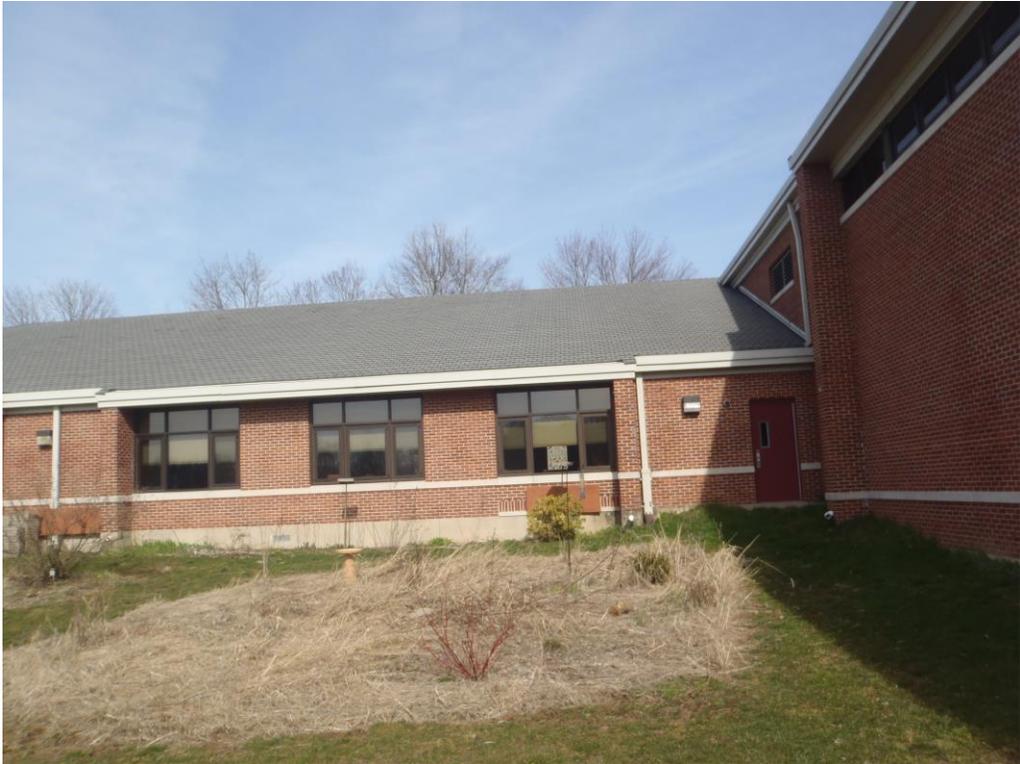
Roofing over wing from the courtyard

Description: The roofing at Lower Milford Elementary is asphalt shingle. It is flashed along the gables and bump outs at exterior columns and is very close to the end of its life cycle.

- The roofing on Lower Milford Elementary should be removed down to deck and replaced. Contingency should be set aside for replacing any deteriorated sheathing or trusses. The longer this replacement is delayed, the greater likelihood of leakage to the interior of the building.
- BIA reviewed the design drawings for the roof trusses and had limited access to the roof framing, however due to the service life and overall condition of the roof when observed for warps or other defects. Without exhaustive examination of the structure and Engineering studies we cannot say for certain, however, based on the service life of the structure to date, the framing appears adequate for the current loads.

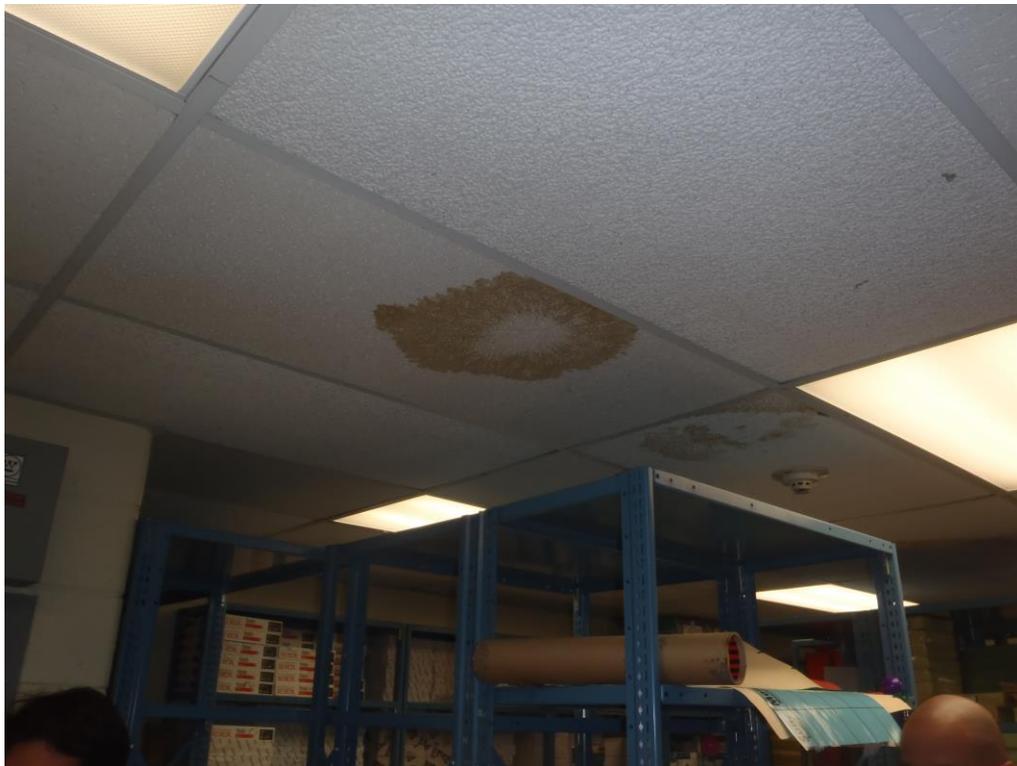
Water Damage
