DISTRICT-WIDE FACILITIES STUDY PRESENTATION

JUNE 25, 2018

Southern Lehigh School District
Existing Facilities Report – High School
5800 Main Street #1, Center Valley, PA 18034

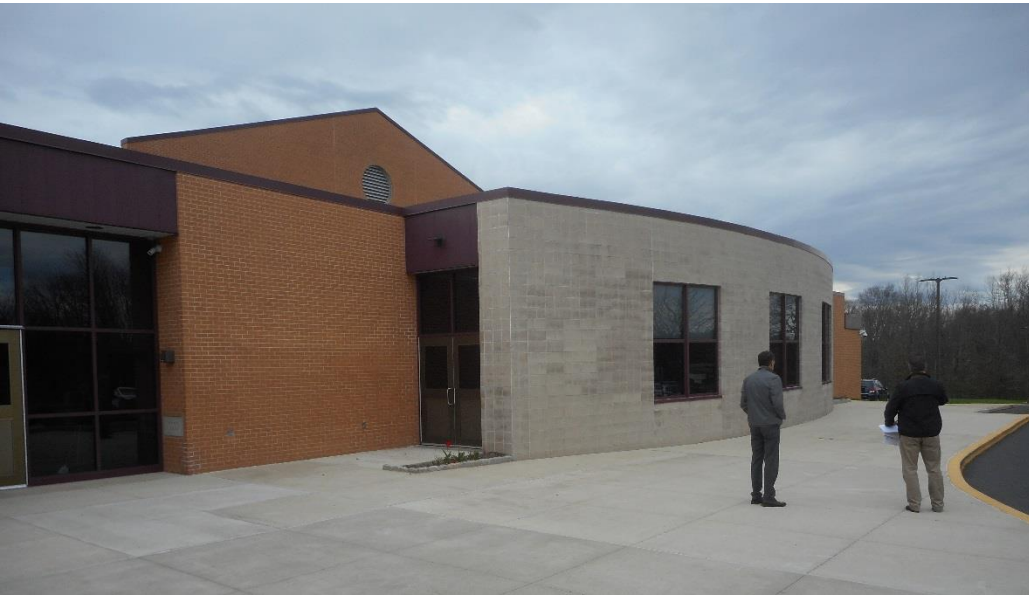
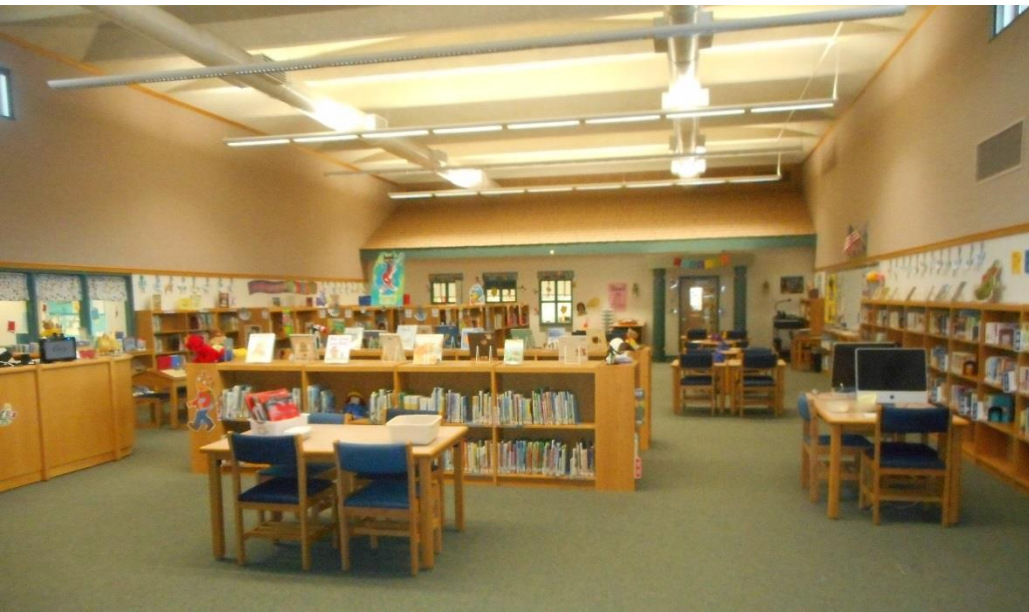
LIBERTY BELL ELEMENTARY SCHOOL

Age: Built 1963; Expanded 1999

Overall Condition: Satisfactory with some systems, equipment and materials in poor condition.

- Driveway/parking in poor condition
- Roofing due for replacement
- Accessibility
- Remove carpet
- Mechanical, electrical and plumbing replacement

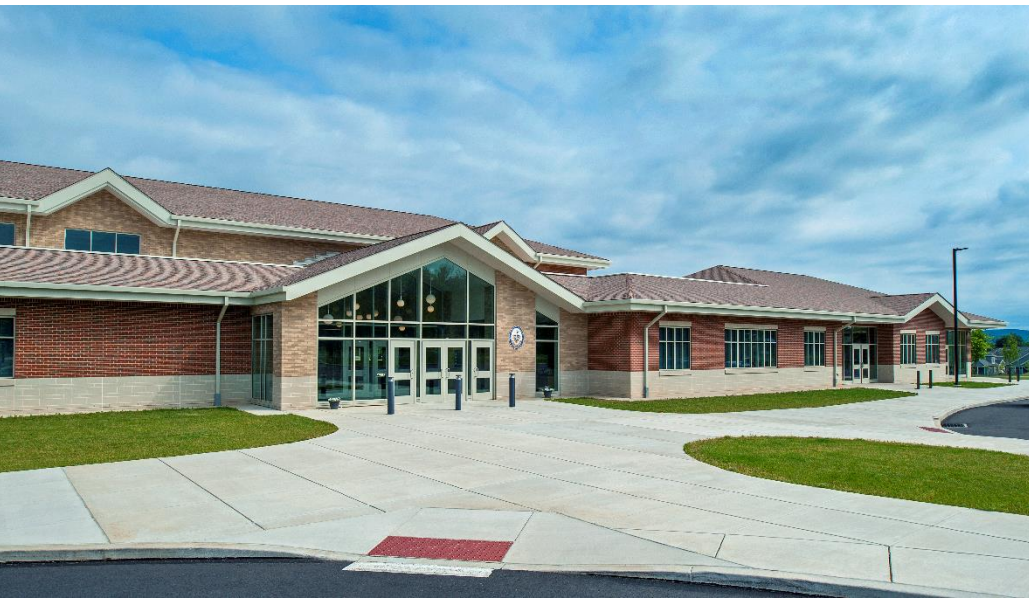
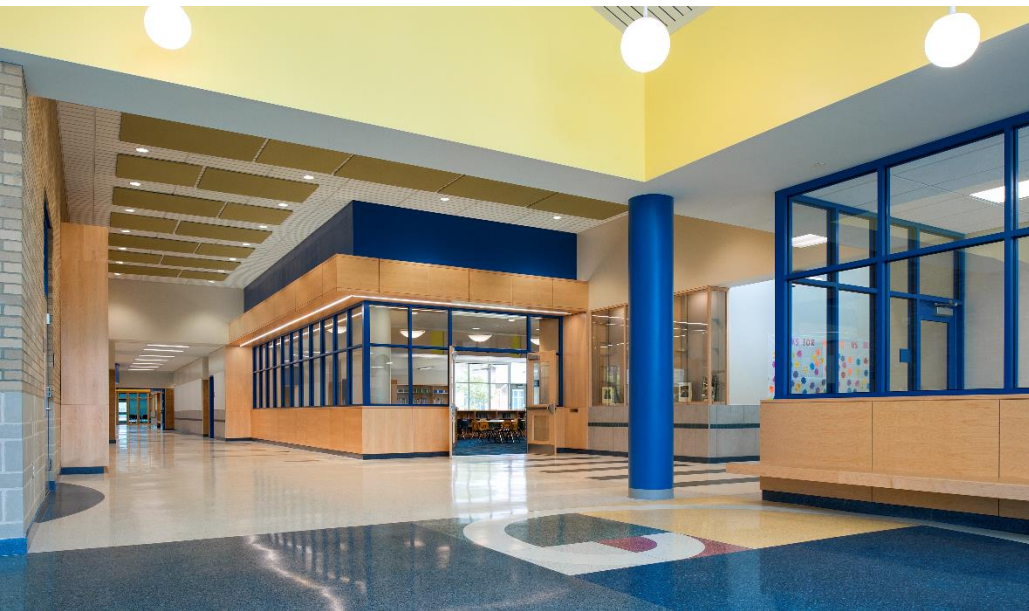
HOPEWELL ELEMENTARY SCHOOL

Age: Built 2016

Overall Condition: Excellent

- High efficiency gas boiler
- Backflow preventer

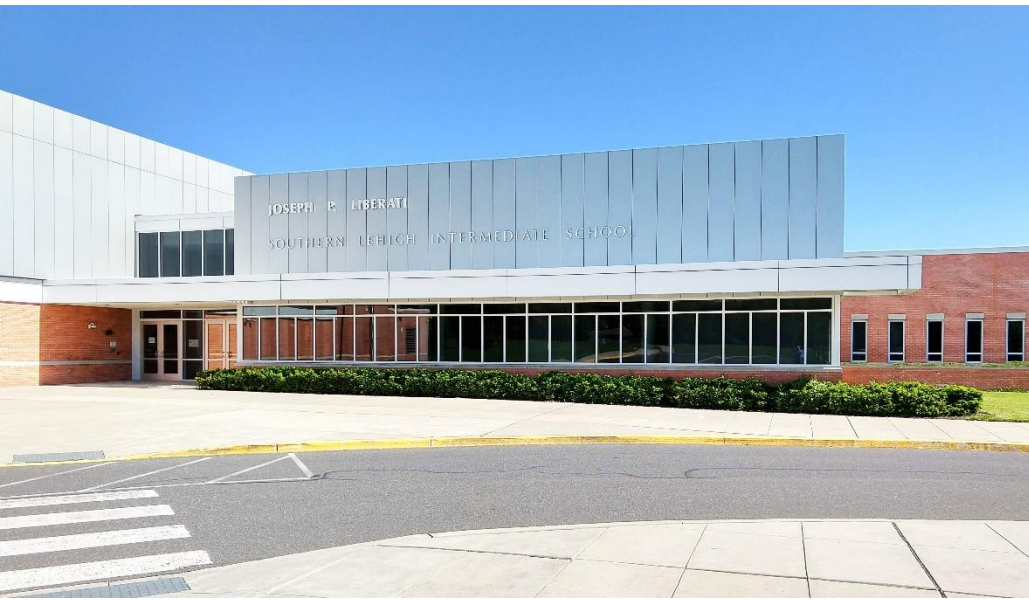
JOSEPH P. LIBERATI INTERMEDIATE SCHOOL

Age: Built 2009

Overall Condition: Good

- Site circulation maintenance
- Acoustics in gym
- High efficiency boilers

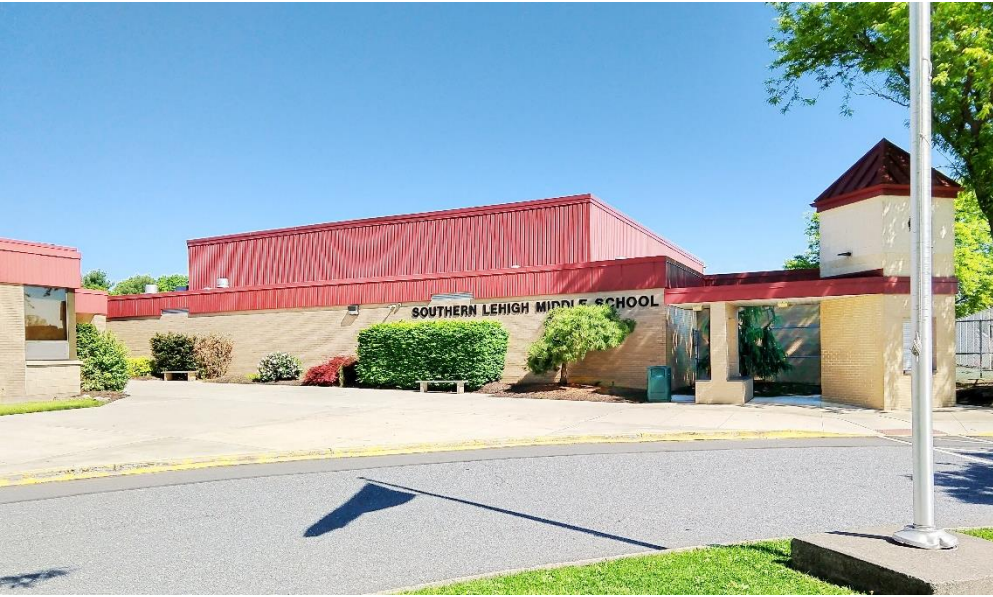
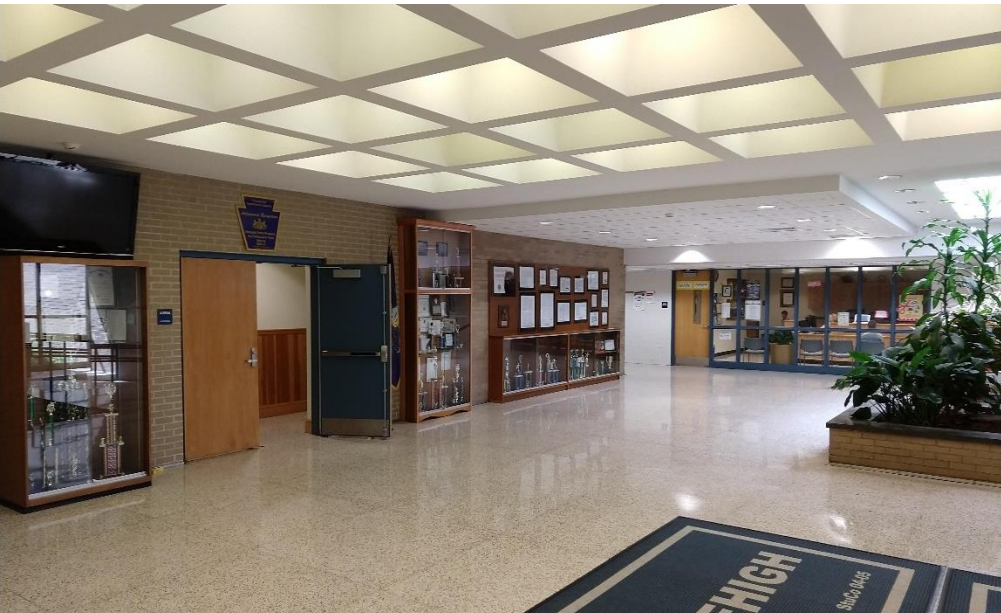
SOUTHERN LEHIGH MIDDLE SCHOOL

Age: Built 1966; several renovation projects (most recent was 1998)

Overall Condition: Poor

- Site circulation maintenance
- Accessibility
- HVAC controls, dehumidification & efficiency improvements
- Additional electric needed in classrooms
- Stage systems

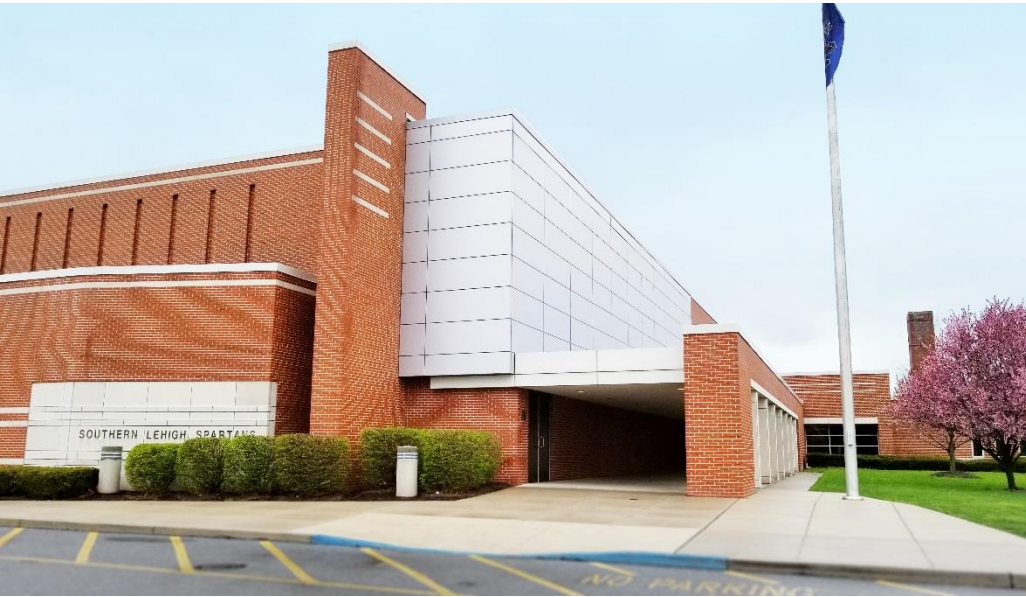
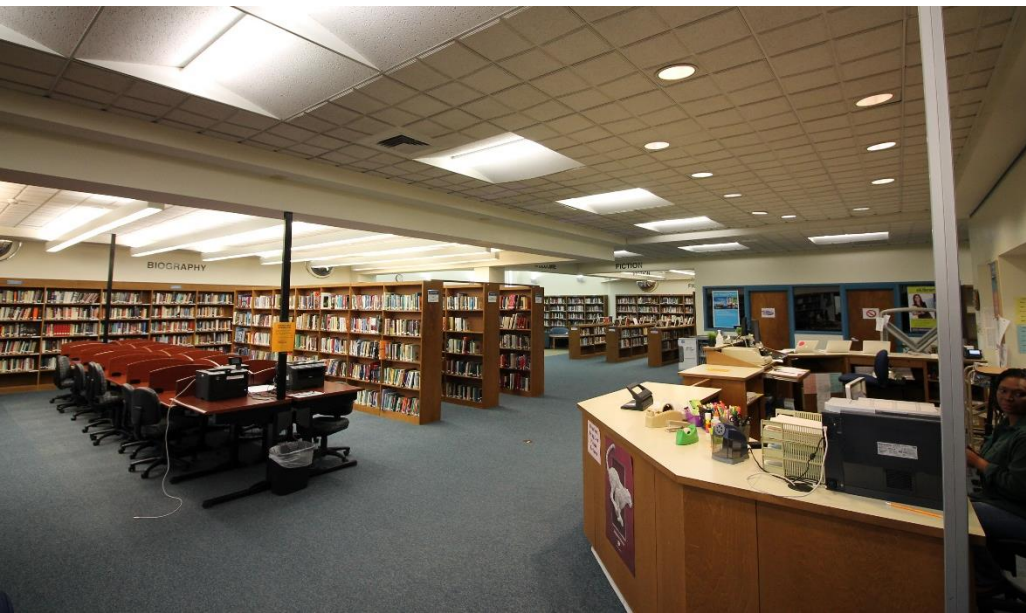
SOUTHERN LEHIGH HIGH SCHOOL

Age: Built 1955; several renovation projects (most recent was 2003)

Overall Condition: Satisfactory/Poor

- Exterior circulation condition
- Roof replacement
- Accessibility
- Old materials and equipment
- Mechanical system upgrades

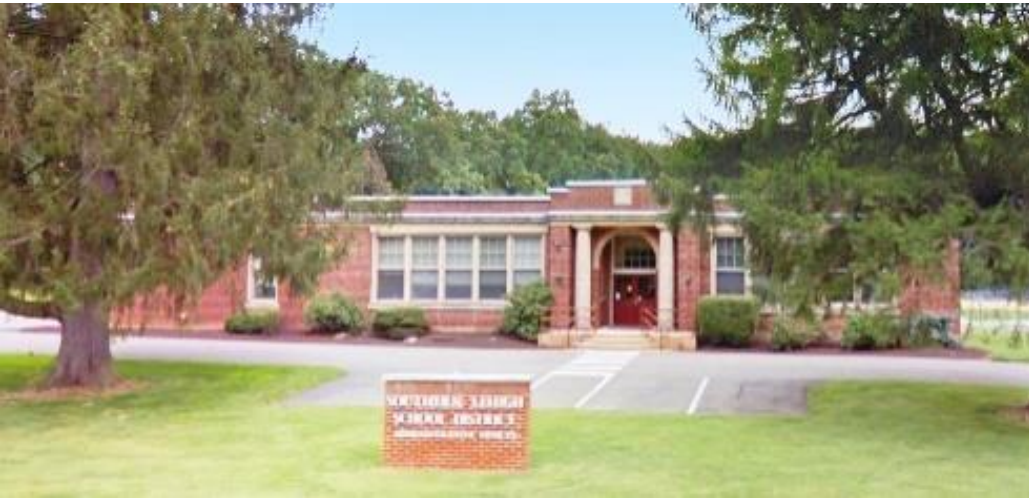
DISTRICT ADMINISTRATION OFFICE

Age: Built 1924, renovated 1992

Overall Condition: Poor

- Age of material and systems
- Air/water leakage in building envelope
- HVAC system
